# Manhole Inspection Summary

Manhole # S25K\_\_032MH

Insp Date: **1/30/09 2:17 PM**

**Location** Address: **1225 W. Pratt**

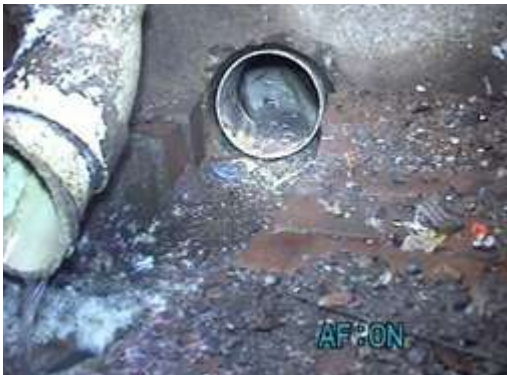
Misc

abandoned line

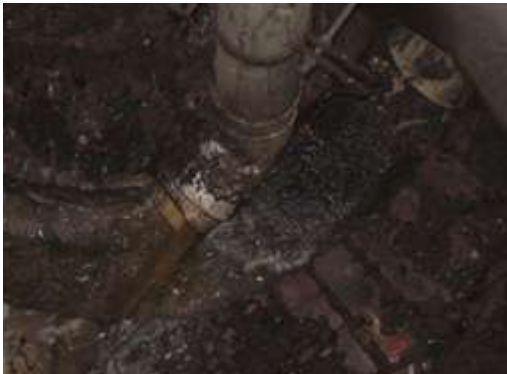
Misc

service line

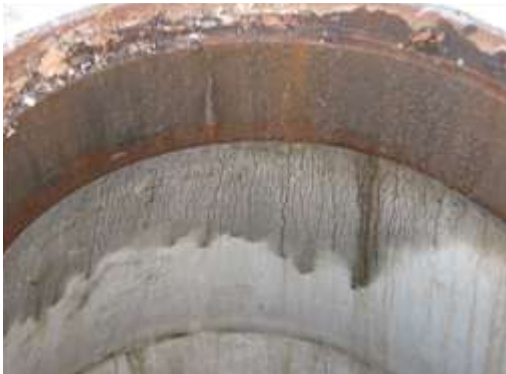
Defect 3

**Frame** Offset: **0** (in.) Condition: ☐ Sound ☐ Cracked ☒ **Leaks**

frame infiltration at cover

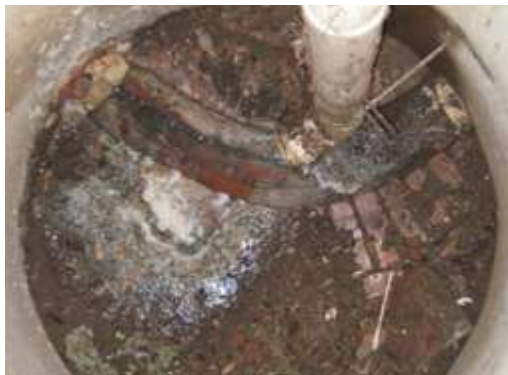
Defect 2

bench debris

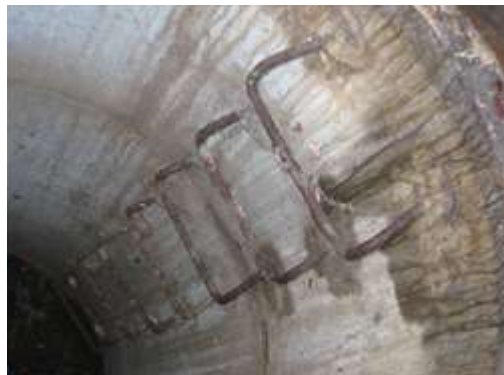
Defect 1

Infiltration: ☐ None ☒ **Joint** ☐ Cracks ☐ Mortar ☐ Roots ☐ Wall

**Steps** Count: **9** Missing: **0** ☒ **Corroded**

chimney infiltration at frame joint, steps  
corroded

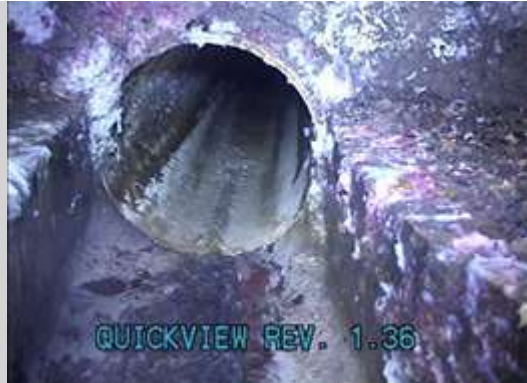
12 O'Clock Outflow

8 in. Circular Gravity Sewer  
Pipe Out @ 12 O'Clock

Pipe Height: **8.4** (in.) Rod and Bar (Angled)  
Pipe Material: **Clay** ☐ Pipe Lined  
Invert Depth: **10.67** (ft.) Flow Characteristics: **Fast**  
Deposits: ☒ None ☐ Mud ☐ Sludge ☐ Debris ☐ Grease  
Silt Depth: **0** (in.) Deposits Extent:  
Infiltration: **None** Pipe Seal Cond: **Sound**

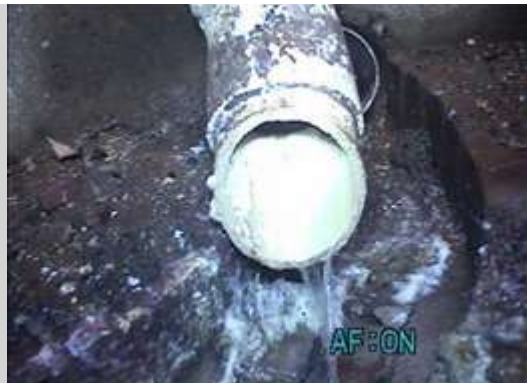
5 O'Clock Inflow

4 in. Circular Gravity Sewer  
Pipe In @ 5 O'Clock

Pipe Height: **3.6** (in.) Rod and Bar (Angled)  
Pipe Material: **PVC** ☐ Pipe Lined  
Invert Depth: **10.00** (ft.) Flow Characteristics: **Fast**  
Deposits: ☒ None ☐ Mud ☐ Sludge ☐ Debris ☐ Grease  
Silt Depth: **0** (in.) Deposits Extent:  
Infiltration: **None** Pipe Seal Cond: **Sound**

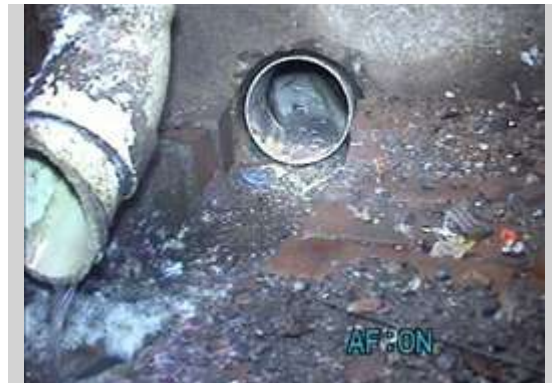
Misc

abandoned line
